# Thin Layer Deposition Projects

January 9<sup>th</sup>, 2018 – Rob Tunstead

# Thin-Layer Deposition / Placement

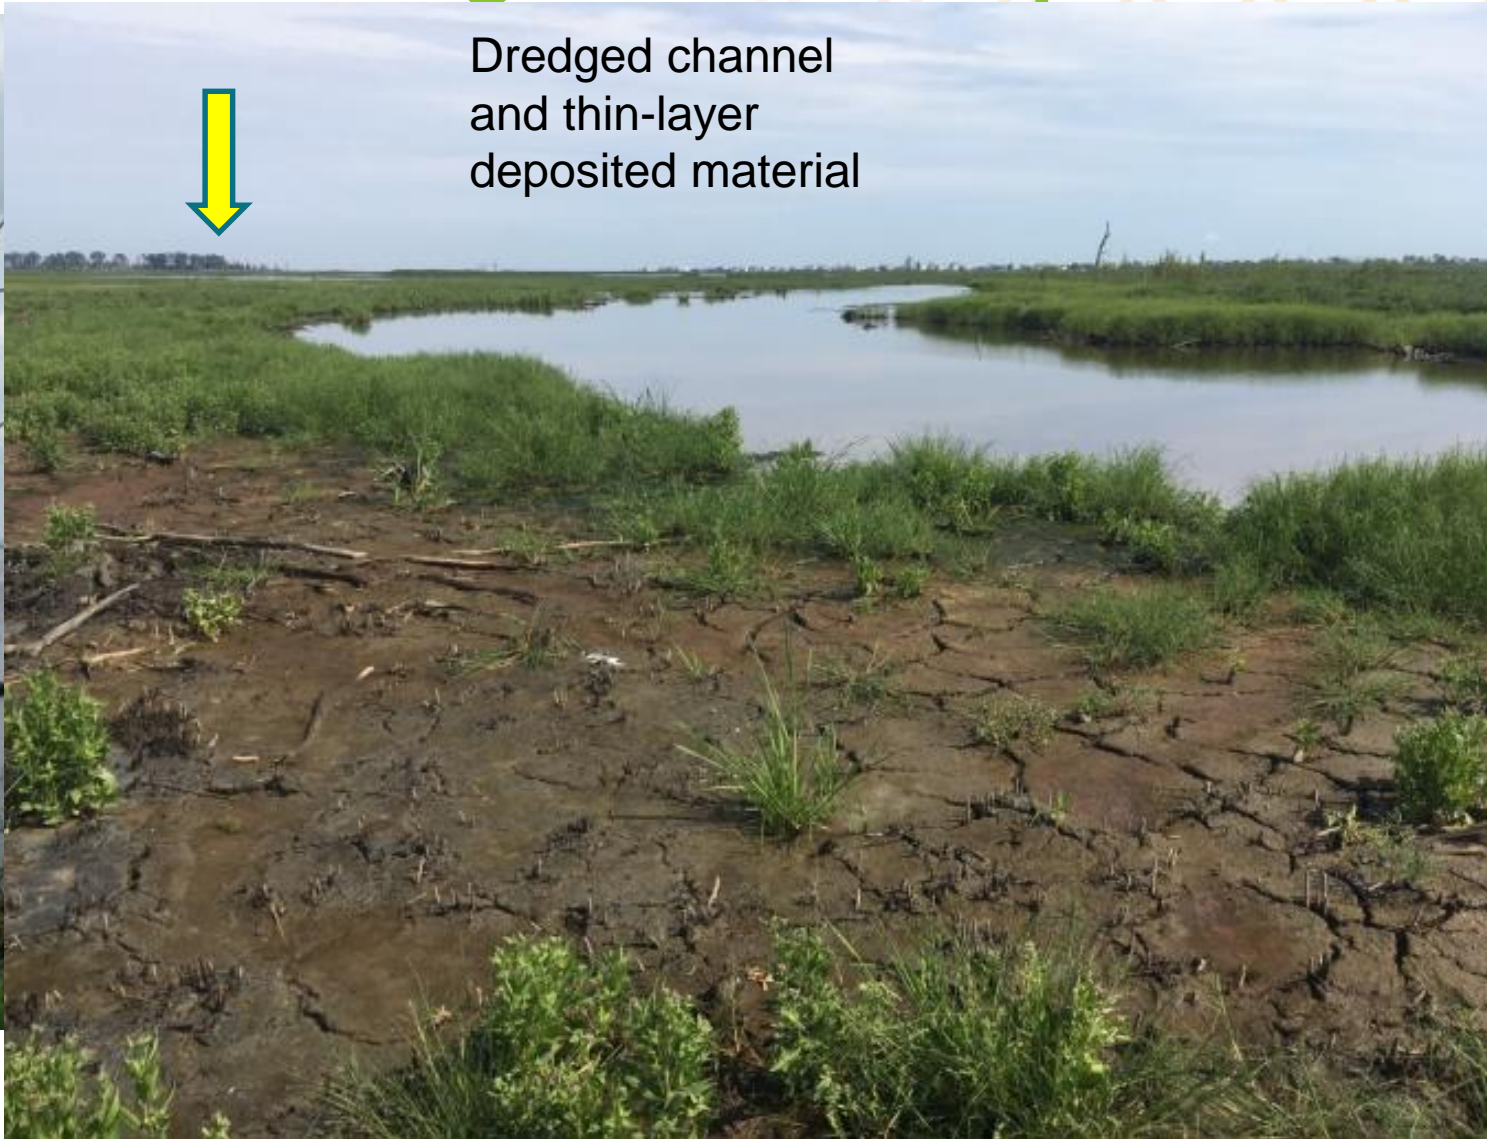
Dredged channel  
and thin-layer  
deposited material

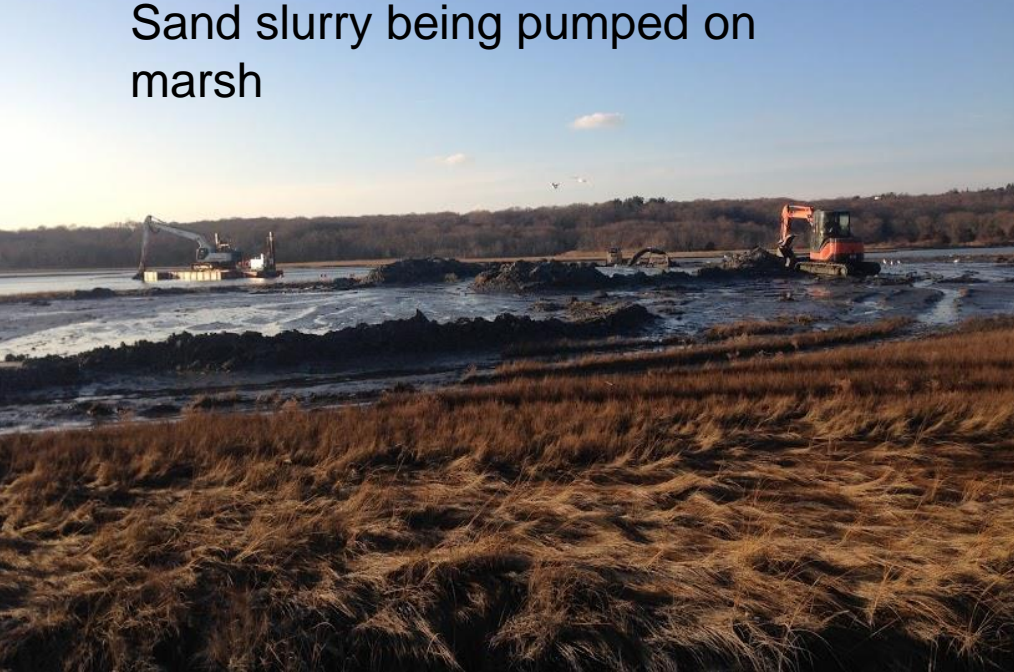
Sand slurry being pumped on marsh

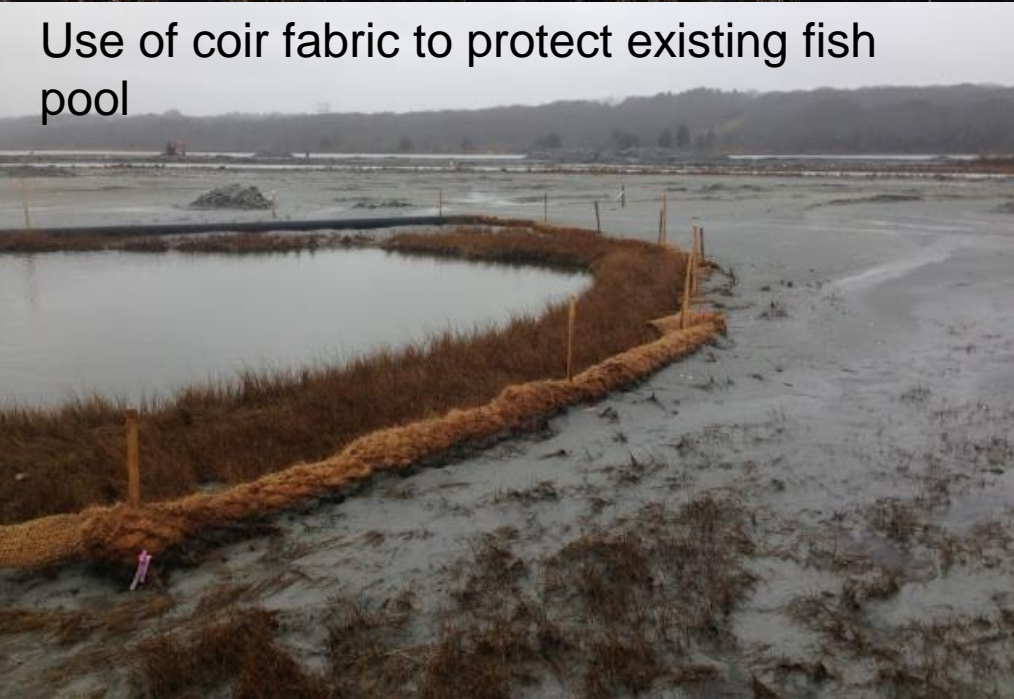
Use of coir fabric to protect existing fish pool

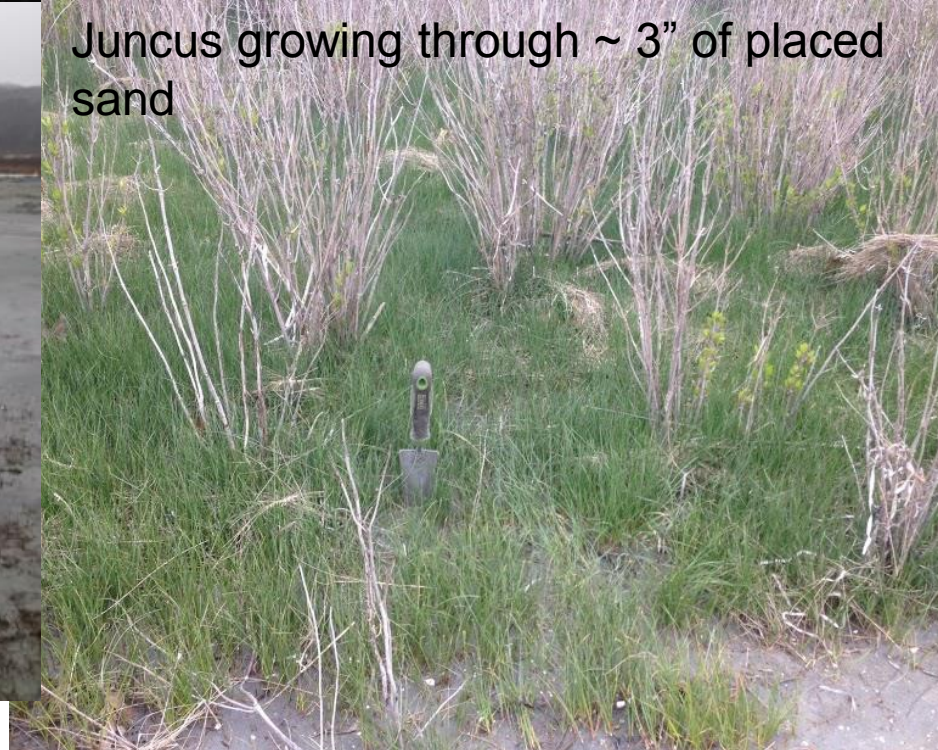
Juncus growing through ~ 3" of placed sand

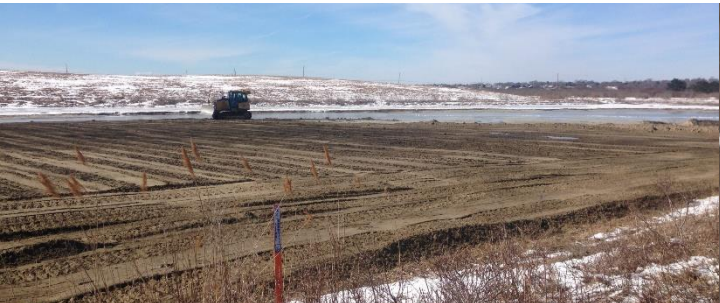
Thin layer deposition of sand from upland source on low marsh area

-conducted in the winter of 2016
